**WASTE MANAGEMENT DIVISION  
RCRA ENFORCEMENT OFFICE  
TSCA COMPLIANCE EVALUATION INSPECTION REPORT**

**Purpose:** TSCA Compliance Evaluation Inspection

**Facility:** Clean Harbors Los Angeles, LLC  
5756 Alba Street  
Los Angeles, CA 90058

**Date of Inspection:** July 16, 2009

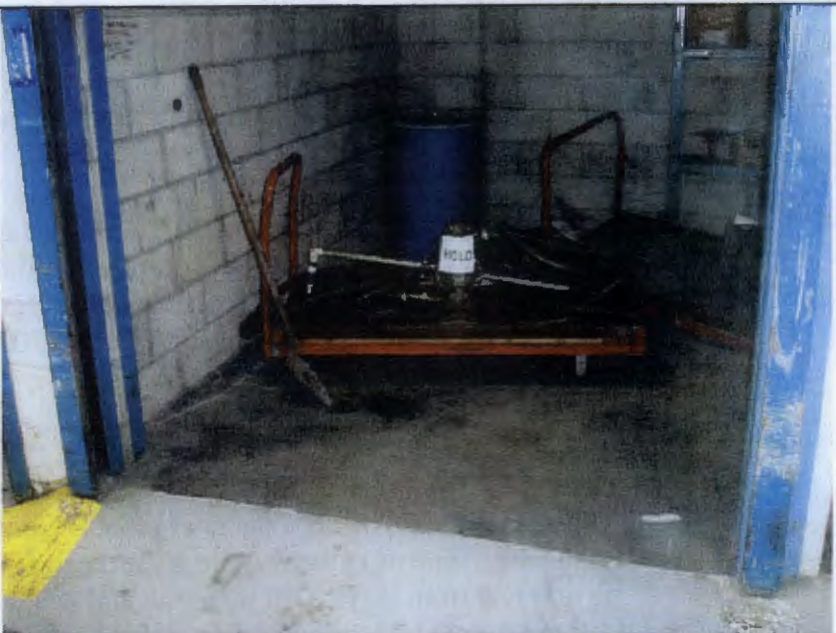
Area: Containment Storage Warehouse	
Location: Bay 2	
Photo: 1A	Date: 7/16/09
Area of Concern: 40 C.F.R. § 761.40 and 40 C.F.R. § 761.65(d)(4)(iv)	
Description: Clean Harbors stored a pump in Bay 2 used to drain PCB equipment on-site. The pump was not marked with a PCB $M_L$ label and oil was observed in the metal pan holding the unit. EPA recommends marking the pump.

Under Condition B(3) of Clean Harbors' September 10, 1991, Commercial Storage Approval, all equipment used for handling PCBs and PCB Items that comes in direct contact with PCBs should be marked with the PCB M<sub>L</sub> label [40 C.F.R. § 761.45(a)].

During EPA's inspection, the facility did not label the pump used in draining PCB liquids from transformers on-site. On September 3, 2009, the facility returned to compliance by marking the pump with a PCB M<sub>L</sub> label.

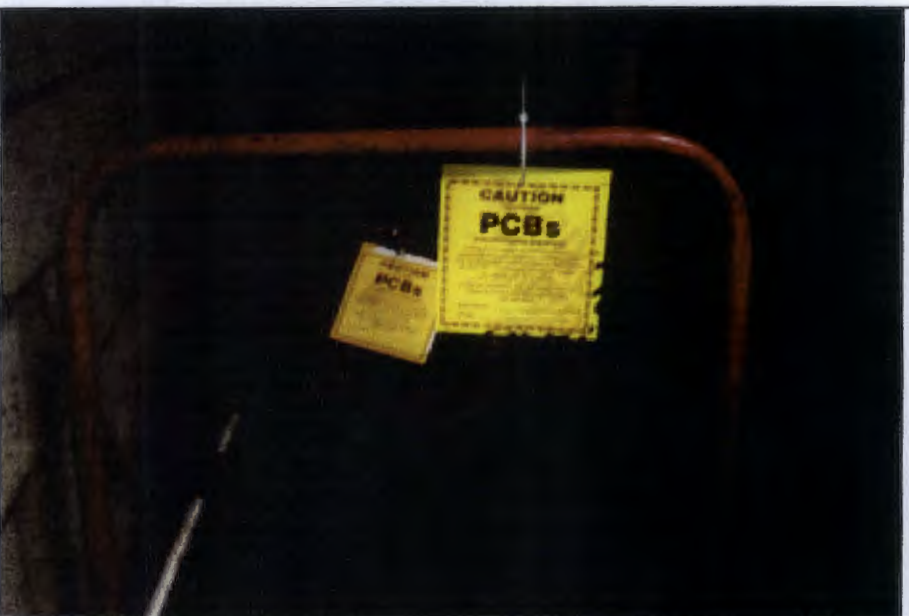
Area: Containment Storage Warehouse	
Location: Bay 2	
Photo: 1B	Date: 7/16/09
Return To Compliance: <b>September 3, 2009</b>	
Description: Clean Harbors returned to compliance by marking their cart for their PCB containing equipment with a PCB $M_L$ label.

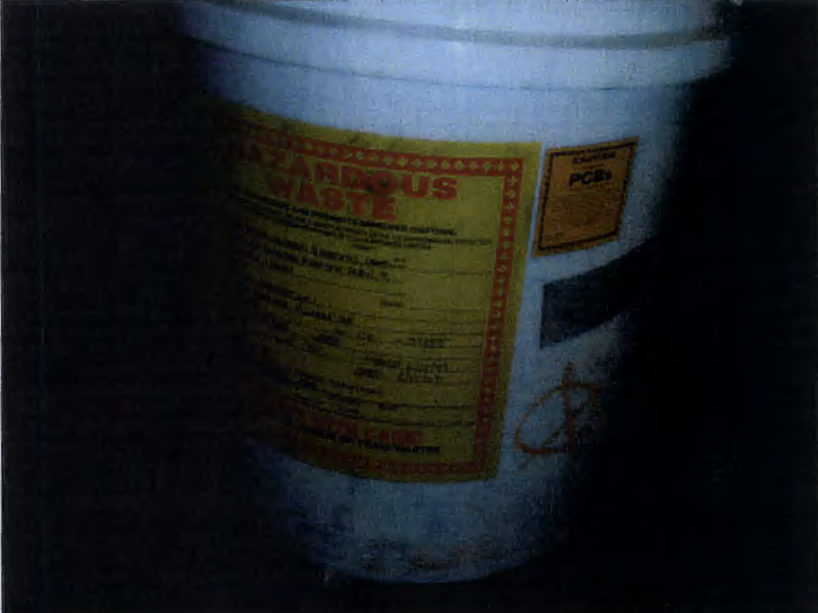
<b>Location:</b> Bay 4	
<b>Photo:</b> 1C <b>Date:</b> 7/16/09	
<b>Potential Violations:</b> <b>40 C.F.R. § 761.45(a)</b>	
<b>Description:</b> EPA documented one-5 gallon container of PCB capacitors marked with a small PCB M <sub>S</sub> label instead of the PCB M <sub>L</sub> label. The container was located in Bay 4 of Clean Harbors' Containment Storage Warehouse.

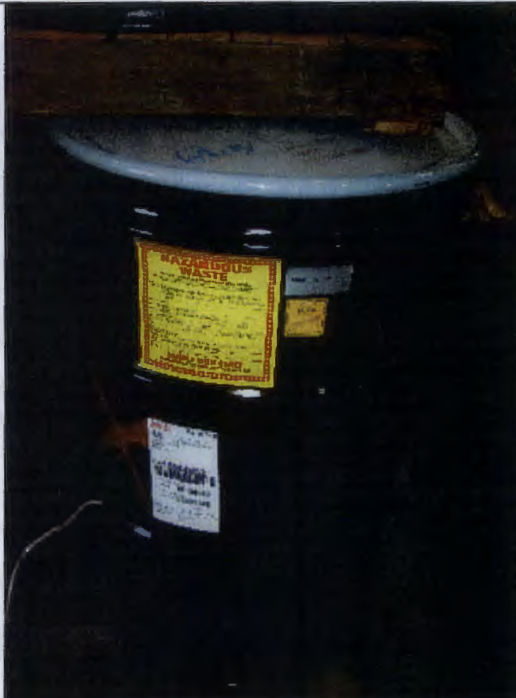
<b>Location:</b> Bay 4	
<b>Photo:</b> 1D <b>Date:</b> 7/16/09	
<b>Potential Violations:</b> <b>40 C.F.R. § 761.45(a)</b>	
<b>Description:</b> EPA also documented one-55 gallon drum of PCB debris and soil in Bay 4 marked with a small PCB label (M <sub>S</sub> ). TSCA requires that a container of this size be marked with an appropriate sized PCB label (M <sub>L</sub> ).

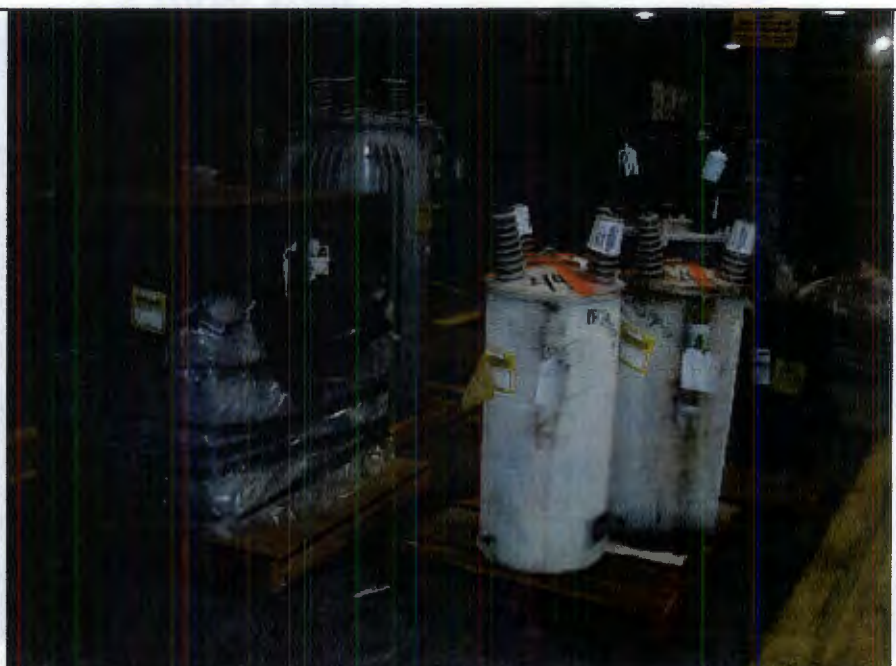
Area: Containment Storage Warehouse	
Location: Bay 5	
Photo: 1E	Date: 7/16/09
Potential Violations: 40 C.F.R. § 761.40(a)(2)	
Description: EPA documented a PCB Transformer at 1,600 ppm without a PCB (M <sub>L</sub> ) label (on the left) on it. Inspectors also observed a PCB label peeling off a transformer in the center of this photograph.

A photograph showing two large, white, cylindrical industrial transformers in a dark warehouse. The transformers are mounted on wooden pallets. The one on the left is partially obscured by a dark, crinkled plastic bag. The one on the right is more visible, showing its top with several black, ribbed insulators and some orange and white labels. The background is dark and indistinct.

EPA observed one unlabeled PCB Transformer (1,600 ppm) in Bay 5 of Clean Harbors' Container Storage Warehouse [Serial # 6688430 (Manifest 002684147)]. Clean Harbors did not generate the PCB waste originally. However, the facility was responsible for the management of the PCB transformer once the waste was received and accepted. As such, Clean Harbor's violated TSCA by not properly marking the PCB container with a M<sub>L</sub> label.

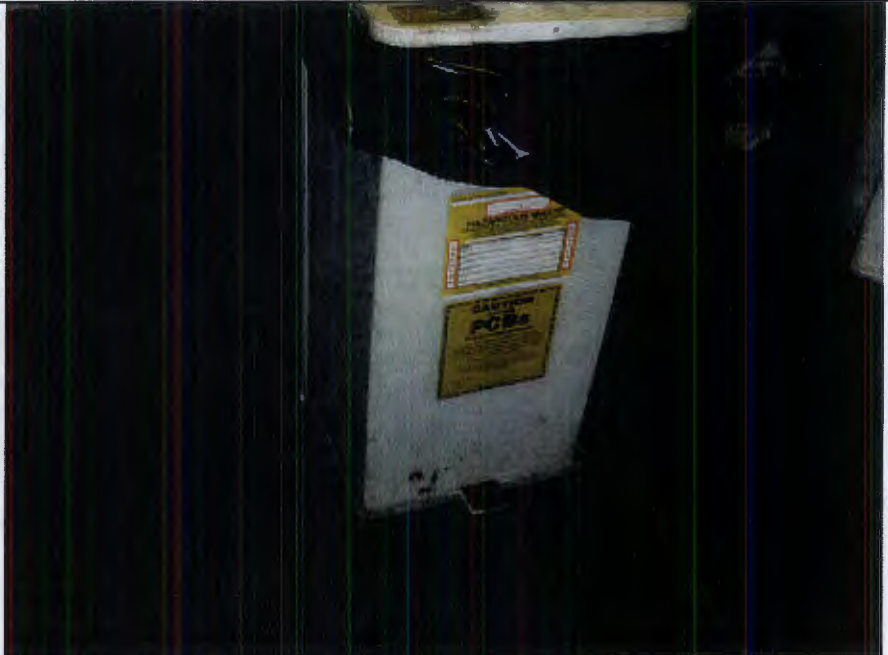
Location: Near Hood #1		
Photo: 3A	Date: 7/16/09	
Potential Violations: <b>40 C.F.R. § 761.65(c)(8)</b>		
Description: Clean Harbors accumulated PCBs in a temporary storage area in their on-site laboratory. The container was not dated to indicate when the first drops of PCBs were placed in the container.

**Comments:** EPA observed a container used for the storage of PCB containing lab vials in the facility's On-Site laboratory. The container did not indicate when the PCBs were first removed from service.

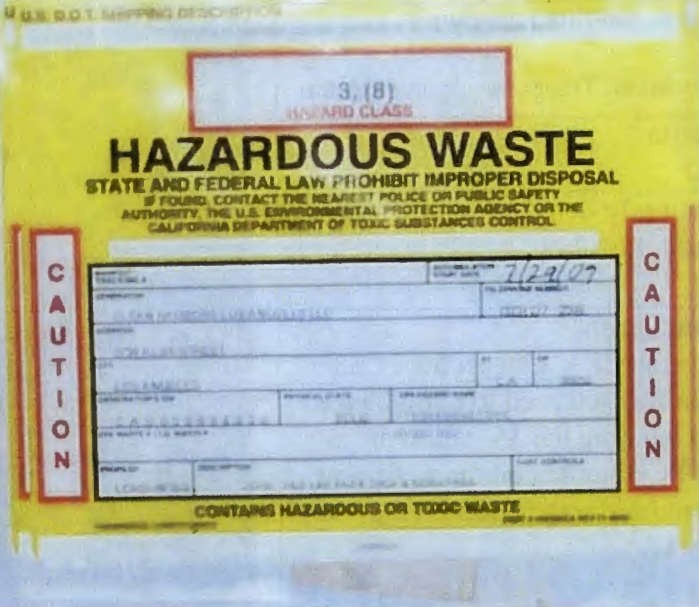
Location: Near Hood #1		
Photo: 3B	Date: 7/30/09	
Return to Compliance: <b>July 29, 2009</b>		
Description: Clean Harbors return to compliance by marking the container (hazardous waste label) with a temporary storage date for the facility's PCB waste.

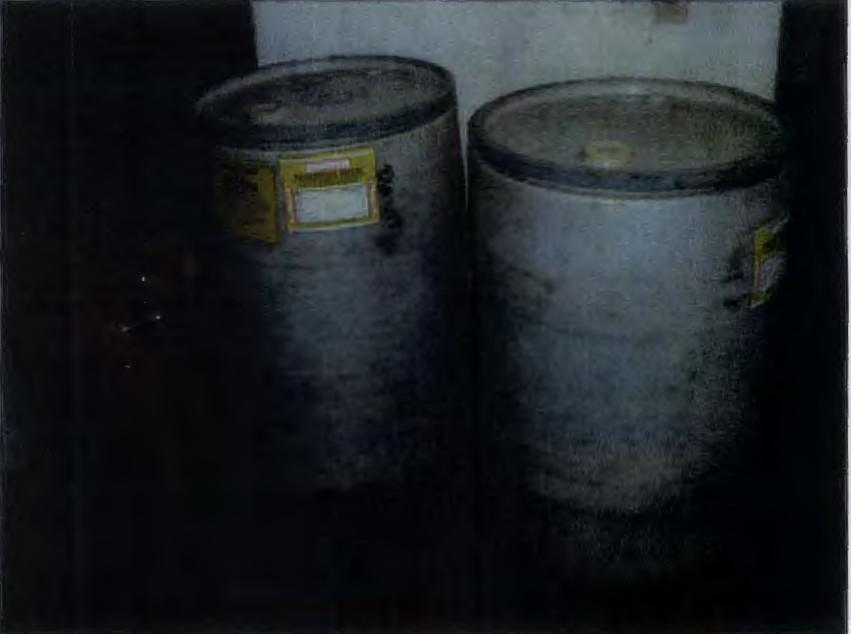
Location: Temporary Storage Area		
Photo: 3C	Date: 7/16/09	
Potential Violations: 40 C.F.R. § 761.40(a) and 40 C.F.R. § 761.65(c)(8)		
Description: Clean Harbors generated two 35-gallon drums of PCB lab waste in their on-site laboratory. One drum was not marked with a PCB M <sub>L</sub> label. Both were not dated with the date placed into temporary storage.

The inspectors also observed one 35-gallon poly container that was not properly marked with a PCB M<sub>L</sub> label and two containers that did not indicate the earliest removal from service dates for the PCBs generated in the lab. In addition, temporary storage areas are required to be marked with the PCB M<sub>L</sub> label under TSCA. Clean Harbors did not properly mark their temporary PCB storage areas.

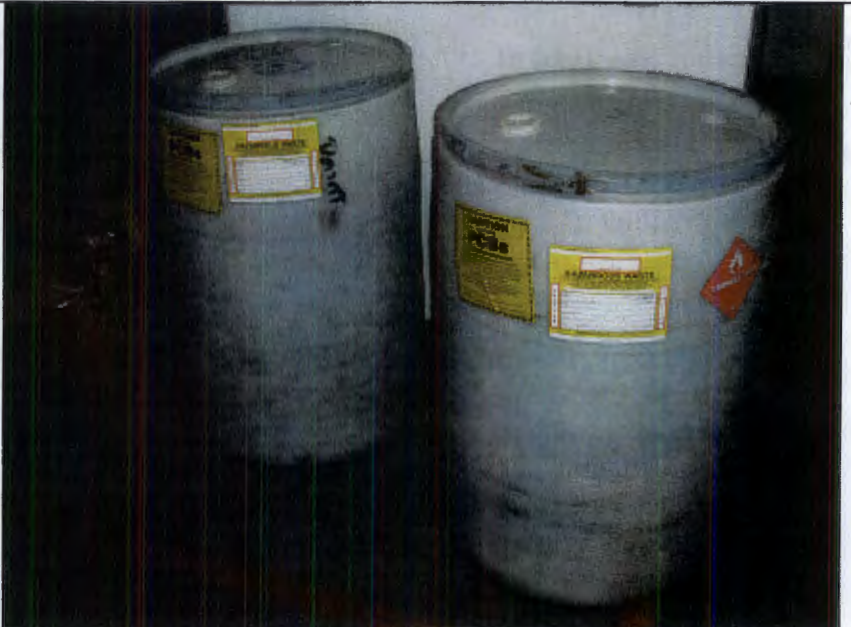
Location: Temporary Storage Area		
Photo: 3D	Date: 7/30/09	
Return To Compliance: <b>July 30, 2009</b>		
Description: During EPA's inspection, Clean Harbors returned to compliance by labeling the 35-gallon drum of PCB liquids on the right, and placing storage dates on the drums.

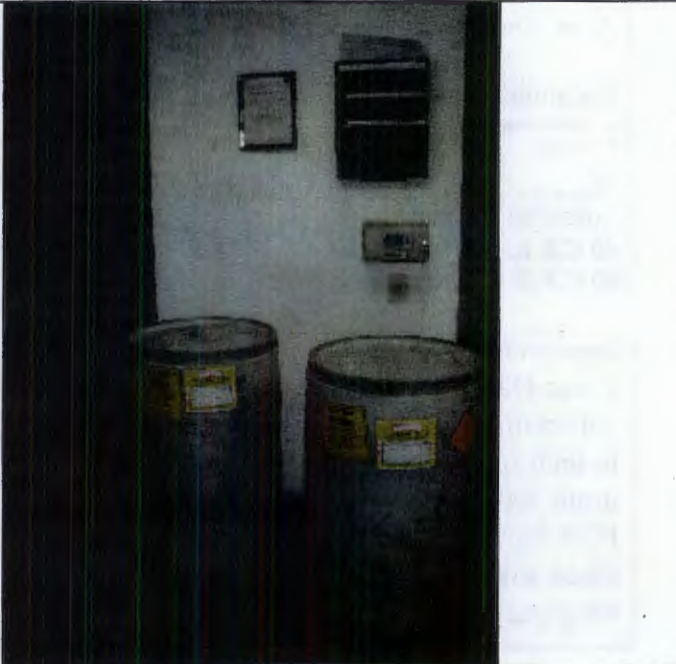
Location: Temporary Storage Area		
Photo: 3E	Date: 7/16/09	
Potential Violations: <b>40 C.F.R. § 761.40(a)(10)</b>		
Description: Clean Harbors failed to mark their temporary storage area with a PCB label as required by law. During the inspection, Clean Harbors stored two 35-gallon poly containers in the temporary area.

On the day of EPA's inspection, Clean Harbors failed to mark their temporary storage area in the facility's On-Site laboratory. The facility documented their return to compliance on July 30, 2009 by marking the temporary storage area with a PCB M<sub>L</sub> label.

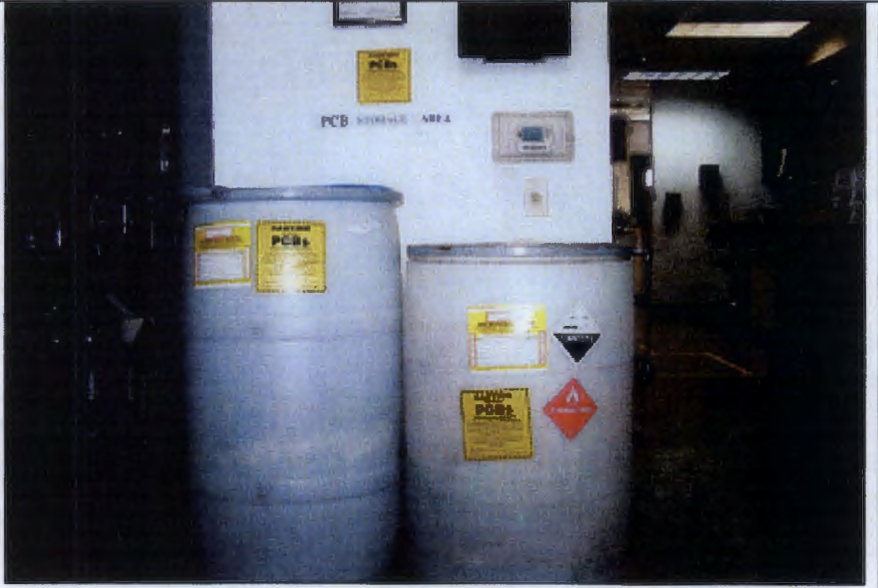
Area: On-Site Laboratory	
Location: Temporary Storage Area	
Photo: 3F	Date: 7/30/09
Return to Compliance: <b>July 30, 2009</b>	
Description: Clean Harbors returned to compliance by marking their temporary PCB storage area in the facility's on-site laboratory.

A photograph showing two large white drums in a storage area. The drums have yellow labels with 'PCB' and 'Hazardous Waste' text. The drum on the right also has a red diamond-shaped hazard label with a flame symbol. Above the drums, a sign on the wall reads 'PCB STORAGE AREA'. The background is dark, suggesting an indoor facility.
